TROUT RUN DAM

National Dam Safety Program. Trout Run Dam (NDI-Pa.-481), Ohio River Basin, Trout Run, Westmoreland County, Pennsylvania. Phase I Inspection Report.

**PHASE I INSPECTION REPORT
NATIONAL DAM INSPECTION PROGRAM**

OCTOBER 1978

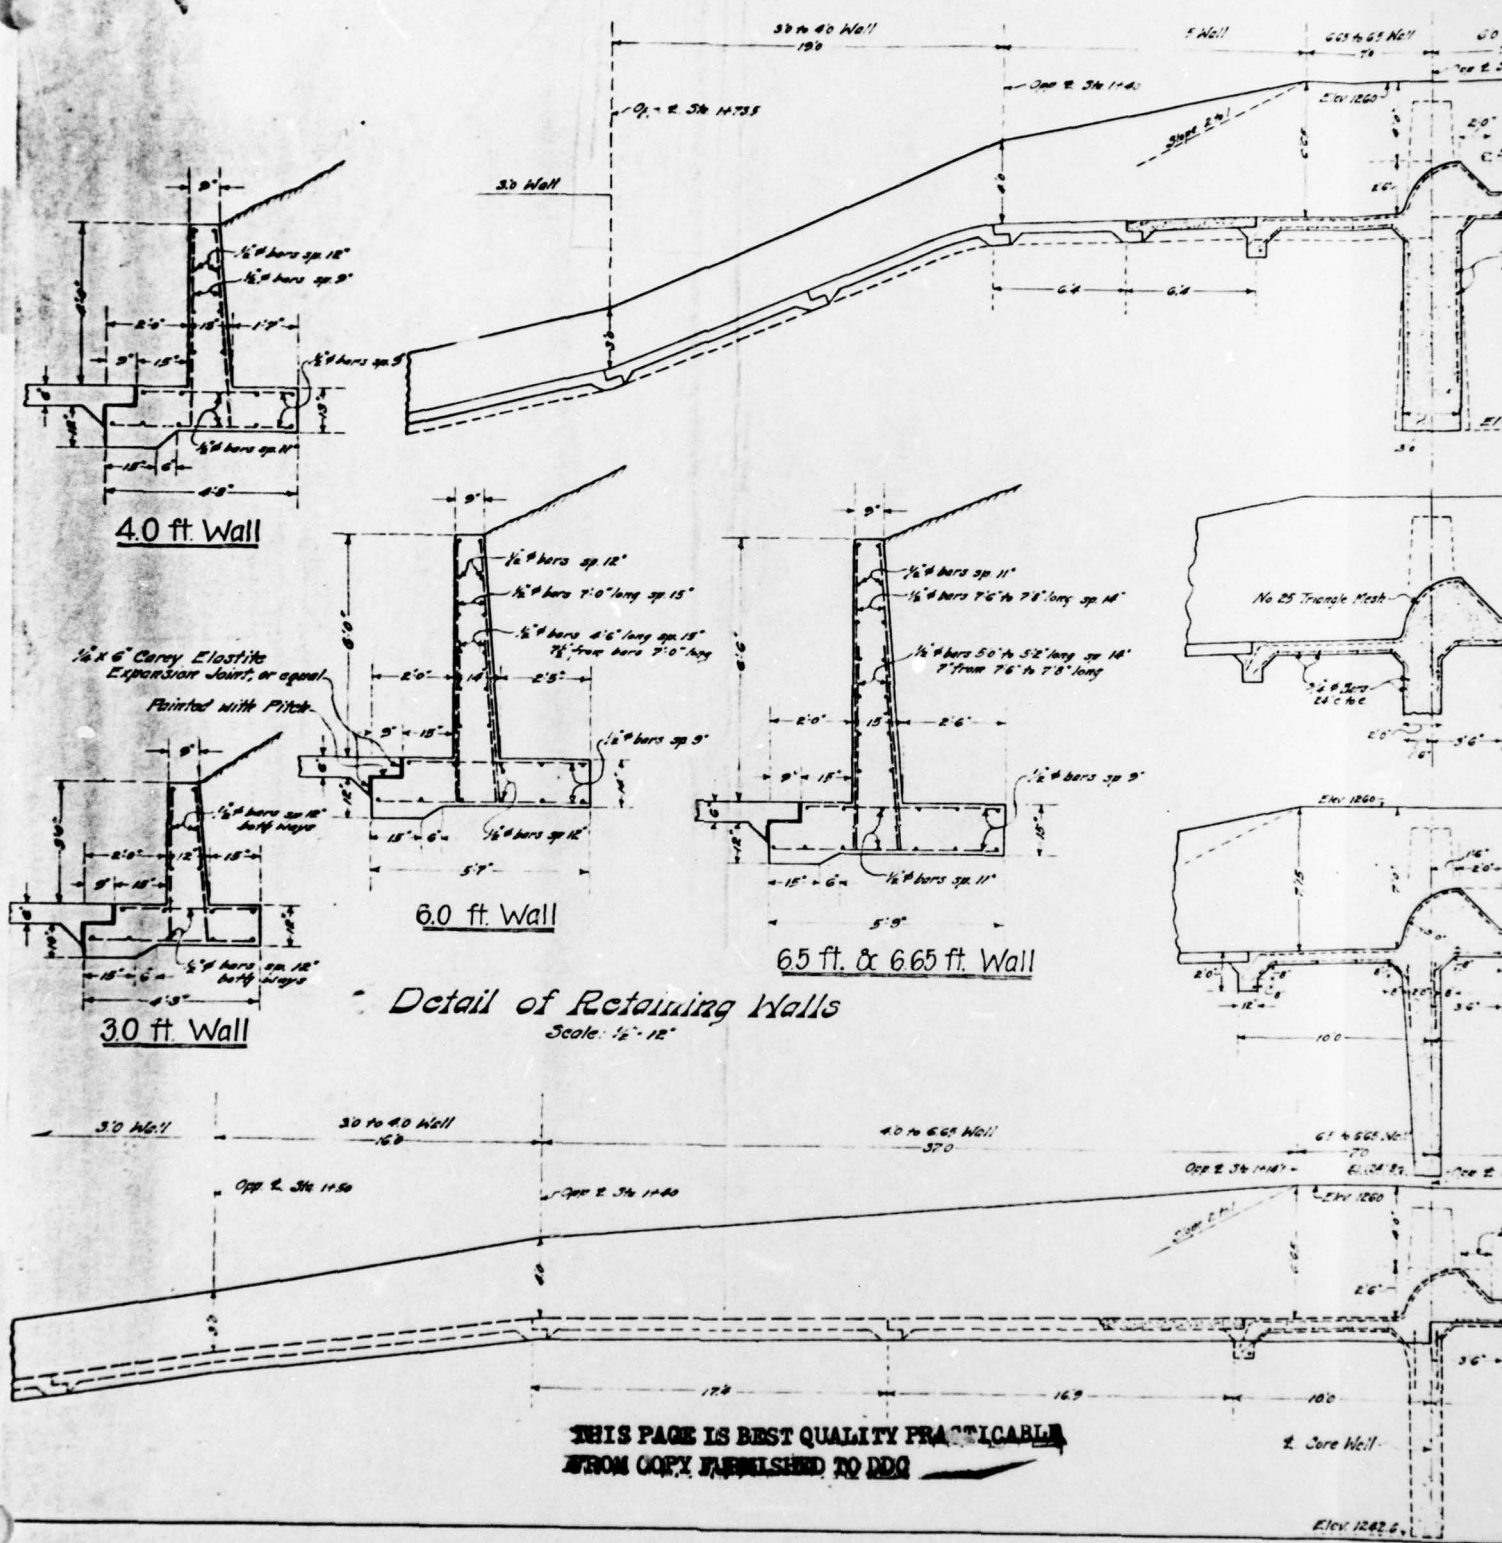
FIGURE 3

1. Embankment. Contract drawings, specifications, and construction reports indicate that the structure is a rolled earthfill structure containing a concrete core wall which was carried down to rock (see Figure 3). The upstream face is mantled with a 12-inch thick layer of stone paving and is sloped at 2.5H:1V. The downstream face is sloped at 2H:1V and the downstream toe is composed of rockfill but it does not appear that any internal drainage system was incorporated into the structure.

Perusal of the contract drawings (see Figures 3 and 4) indicates that the shortest seepage path through the embankment is at a position just to the right of the spillway. It seems possible that water is passing along or below the dam-foundation contact in this area and emerging in the area just above the berm. It is of further interest to note that boring records (see Figure 6) indicate that drilling water was lost and a broken sandstone encountered while drilling

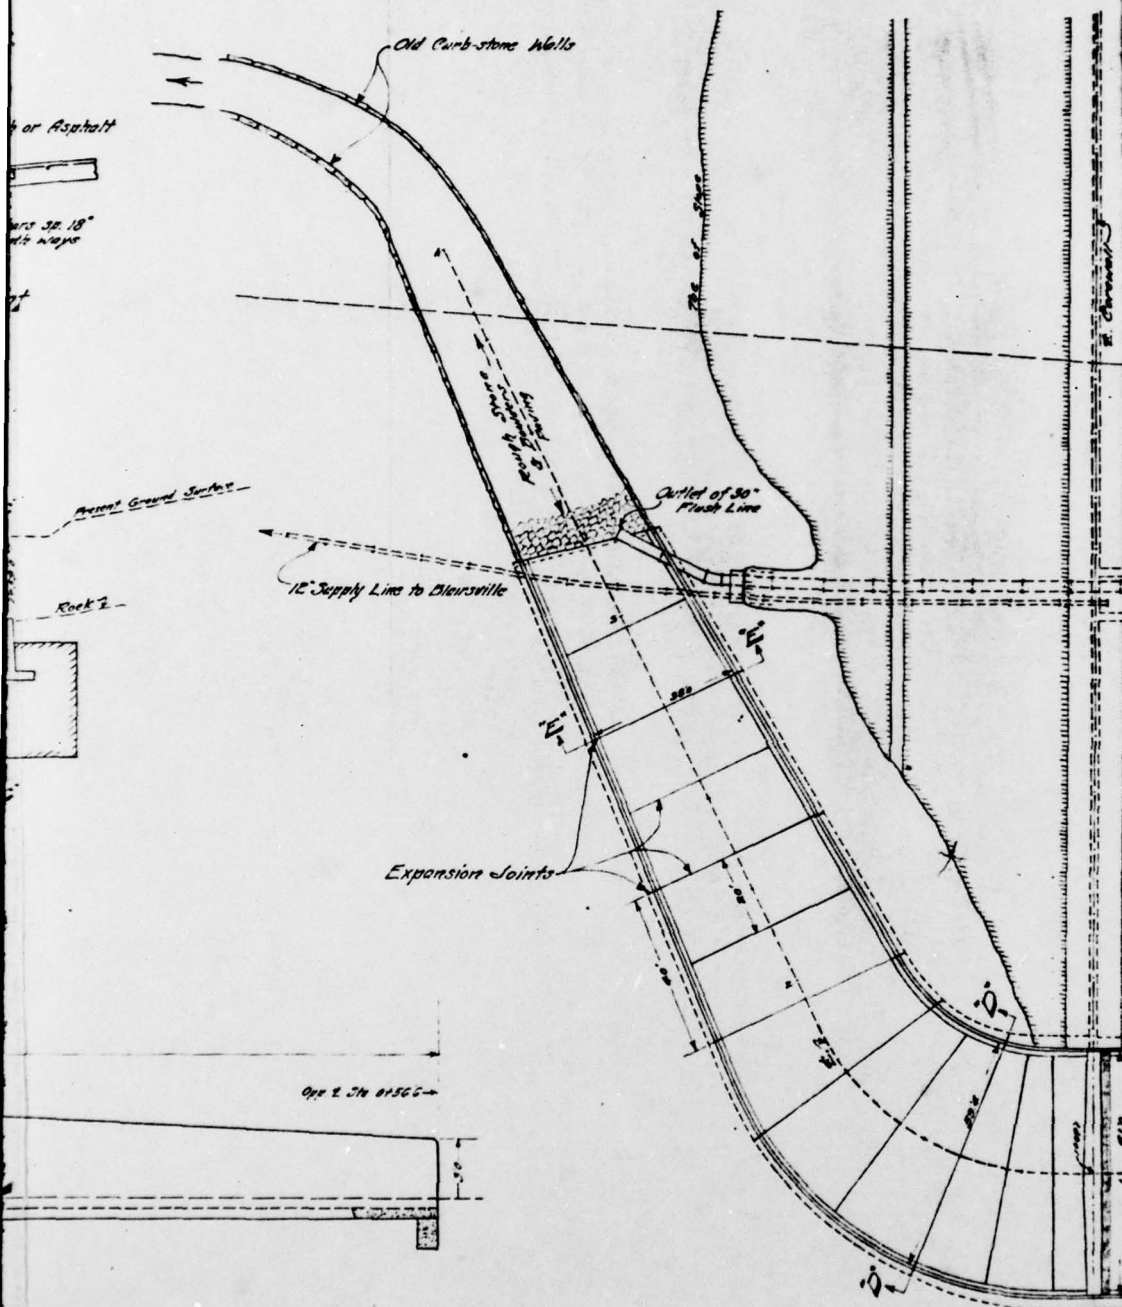
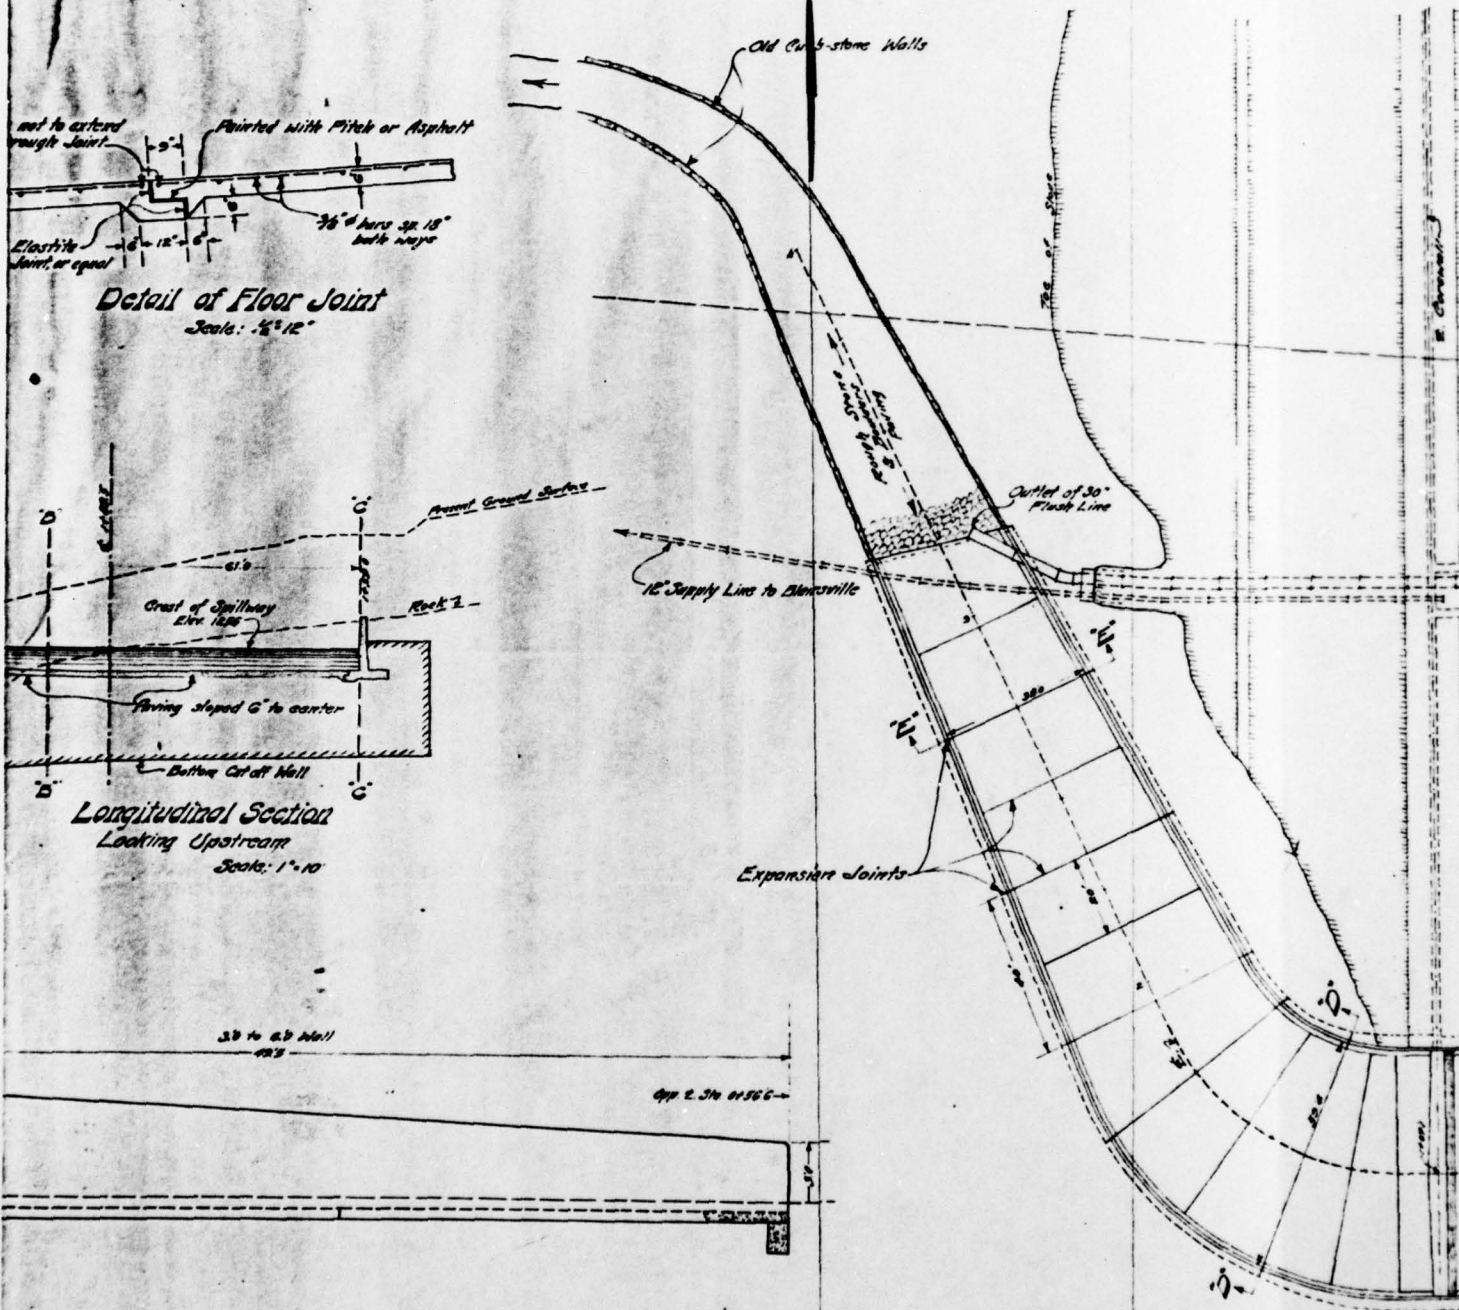
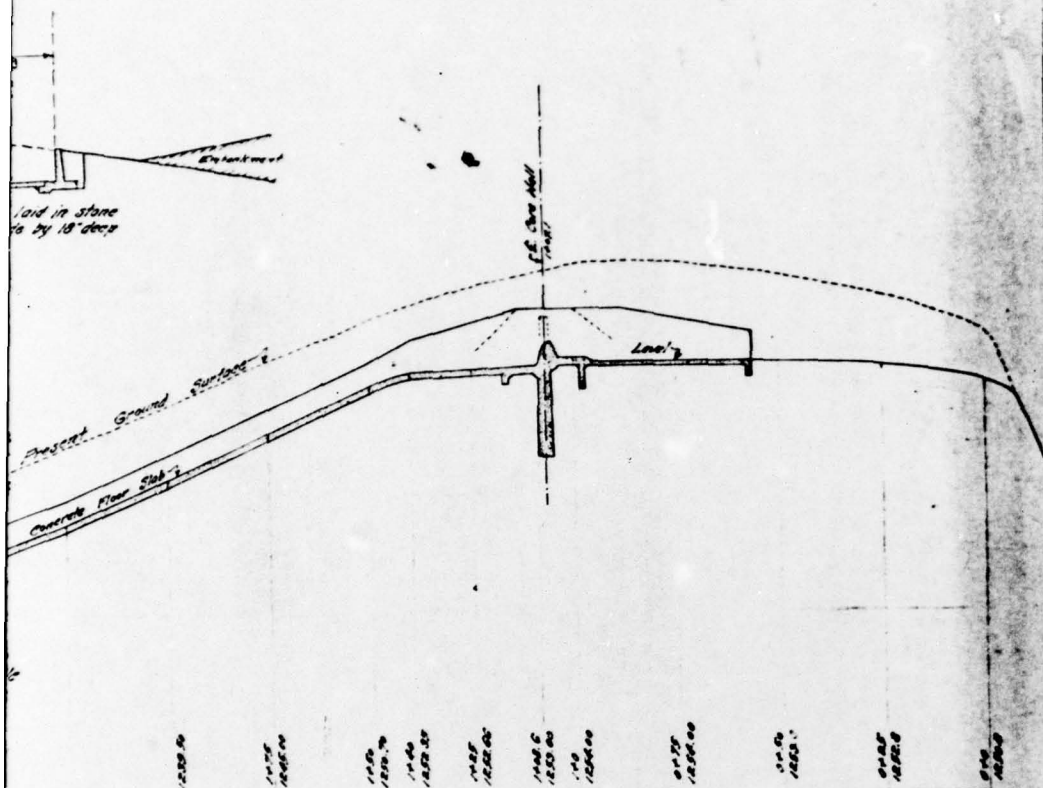
FIGURE 4 (1 of 2)

- a) Spillway. The spillway is an uncontrolled concrete chute type structure with an ogee-shaped crest. A concrete cut-off wall extends beneath the spillway to rock as shown on Figure 4. Two smaller concrete cutoffs were constructed in the approach channel of the spillway. The spillway chute is characterized as a curved rectangular channel which empties into a rock-lined portion of the Trout Run channel approximately 260 feet downstream of the crest.
